## CASE STUDY

# Continuous Bus Duct Monitoring for Data Centers

Frankfurt, Germany

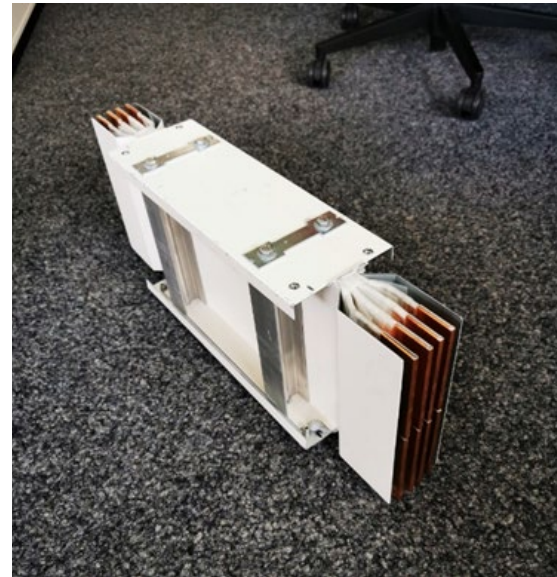
*Schneider 2000A busway – sensor cable route planning and retrofitting by STS Group*

While the cloud facility was in full operation, the fiber optic sensor cable was carefully fitted along the required 2000A ampacity busway using non-metallic fasteners devised by STS Group. This live production data center has busway infrastructure spanning across two levels of the building and crossing more than a dozen separate rooms and corridors and at a typical height of 3 m above the floor level.

Following discussion with Facility Management, STS Group assisted in the CBTM solution. The sensor cable routing is in direct physical contact with the busway housing, with the DTS continuously measuring the busway housing temperature along each feeder, elbow, tee and busway joint.

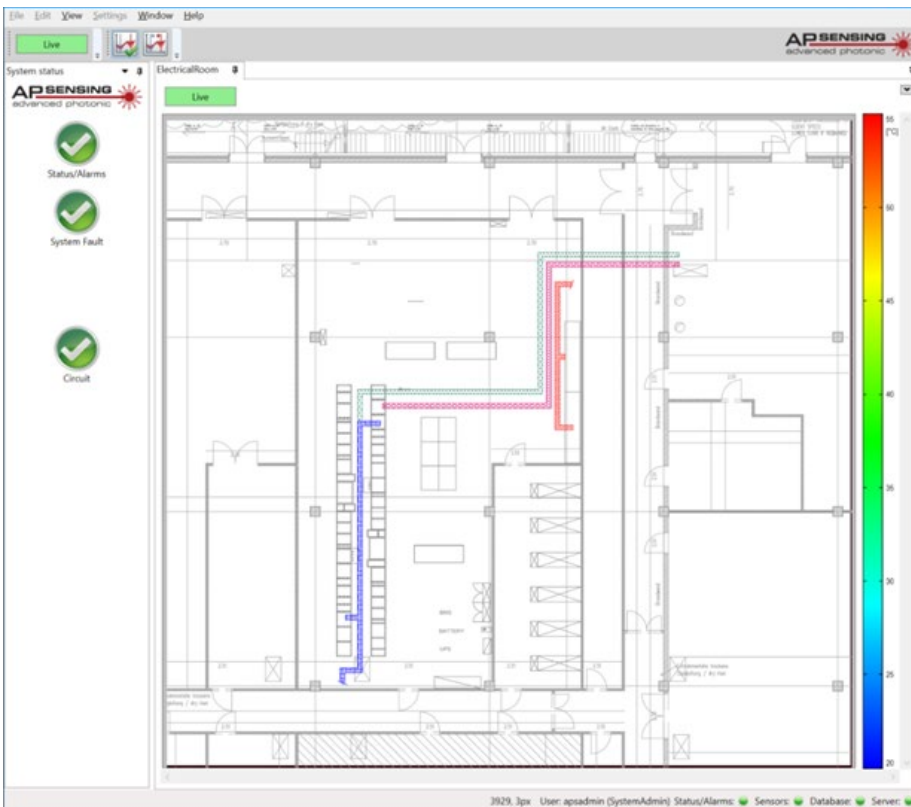
*AP Sensing’s SmartVision AssetView*

SmartVision AssetViewer software provides a visual overview of the entire infrastructure and any points of concern. Having been alerted of a hotspot alarm, the on-site maintenance engineer is able to utilize SmartVision to carry out a local investigation and rapid, detailed assessment without needing physical access to the secure location.
